**Blue Heron Condominiums**  
Murrells Inlet, South Carolina  
Building Envelope Evaluation

**SUBJECT:** Report for Building Envelope Evaluation - 3 Buildings  
Blue Heron Condominiums  
4999 US-17 Business,  
Murrells Inlet, SC 29576  
BECS #20240681

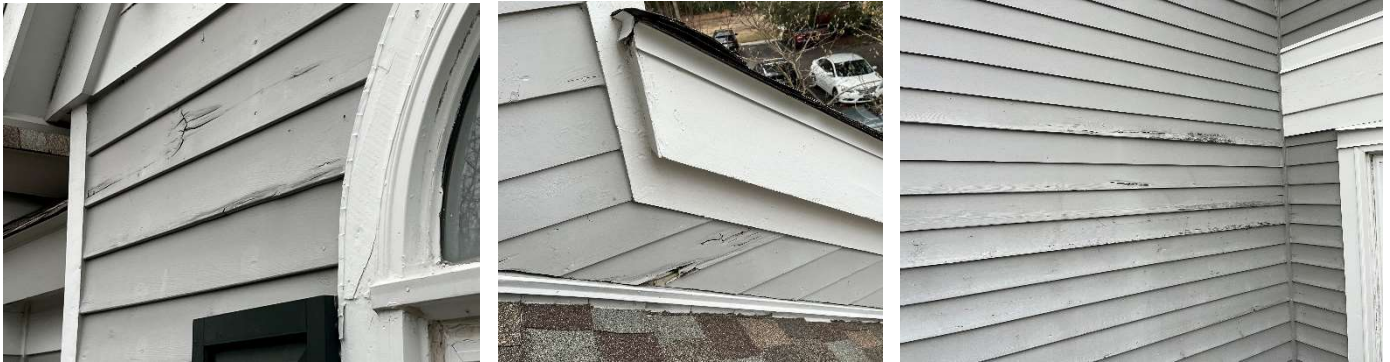
Photos 1, 2, & 3 – Typical rotted siding throughout, numerous locations, multiple building elevations and areas.

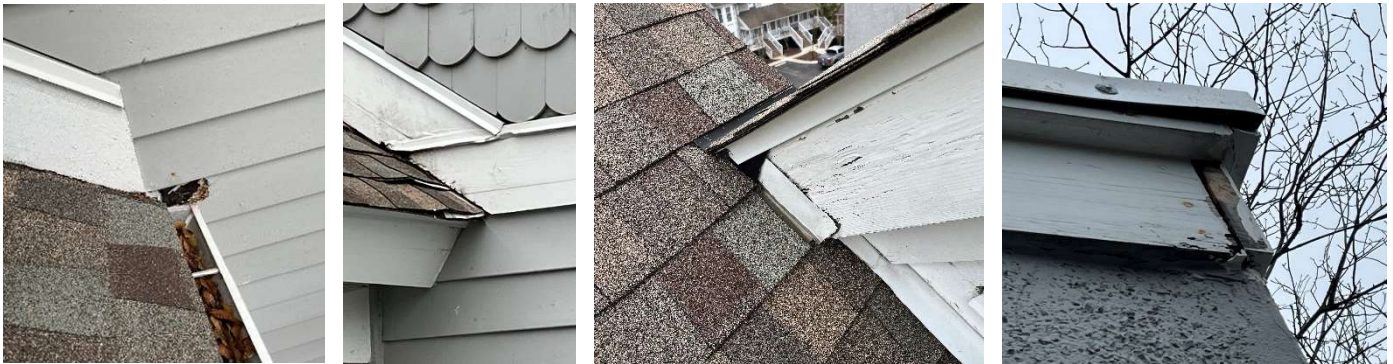
Photos 4, 5, 6, & 7 – Missing kick-out flashing (Left & Center Left), Unflashed step flashing at roof rake (Center Right), and Gap at chimney cap trim (Right).

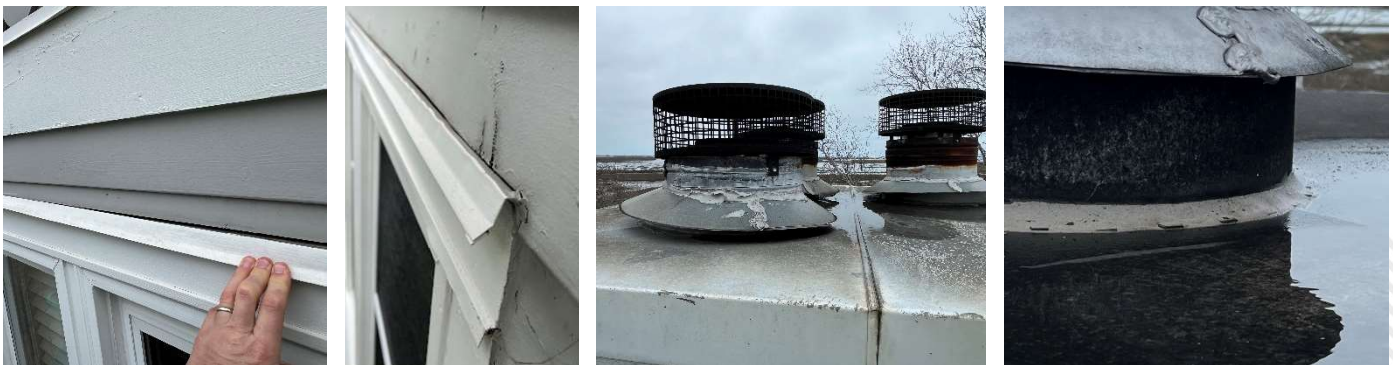
Photos 8, 9, 10, & 11 – Typical window trim flashing negatively sloped (Left & Center Left), Typical ponding water at chimney caps (Center Right), and Gaps at chimney cap/flue flange tabs (Right).

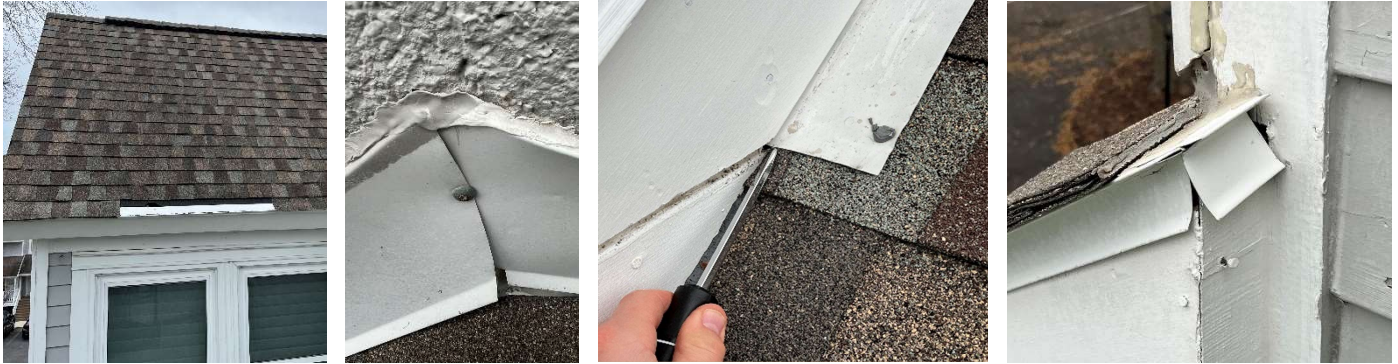
Photos 12, 13, 14, & 15 – Missing shingle at east gable roof (Left), Unsealed counter-flashing at ridge of chimney roof cricket (Center Left), Gap at roof end wall flashing and trim (Center Right), and Gaps at roof trim (Right).

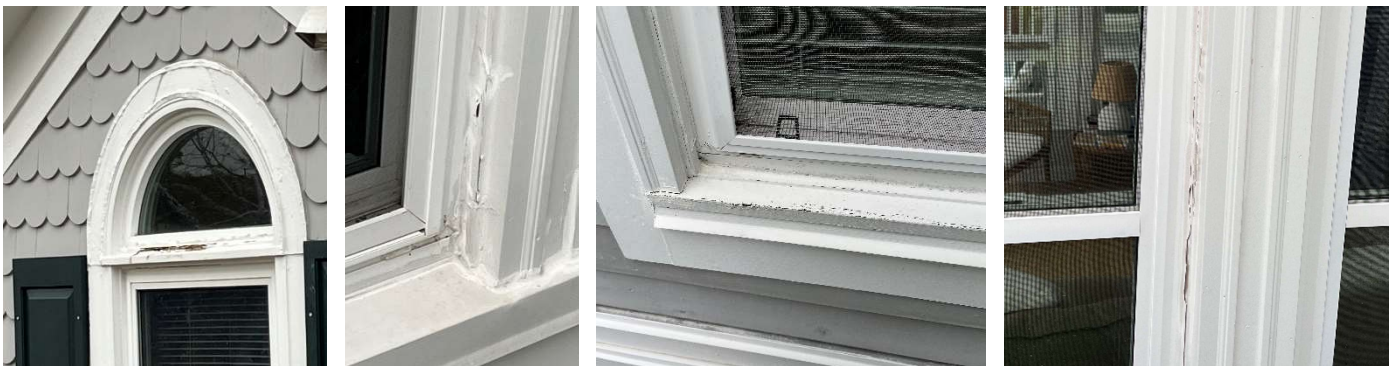
Photos 16, 17, 18, & 19 – Rotted transom window sill (Left), Cracks, openings, and sealant delamination at window frames and trim (Center Left, Center Right, & Right).

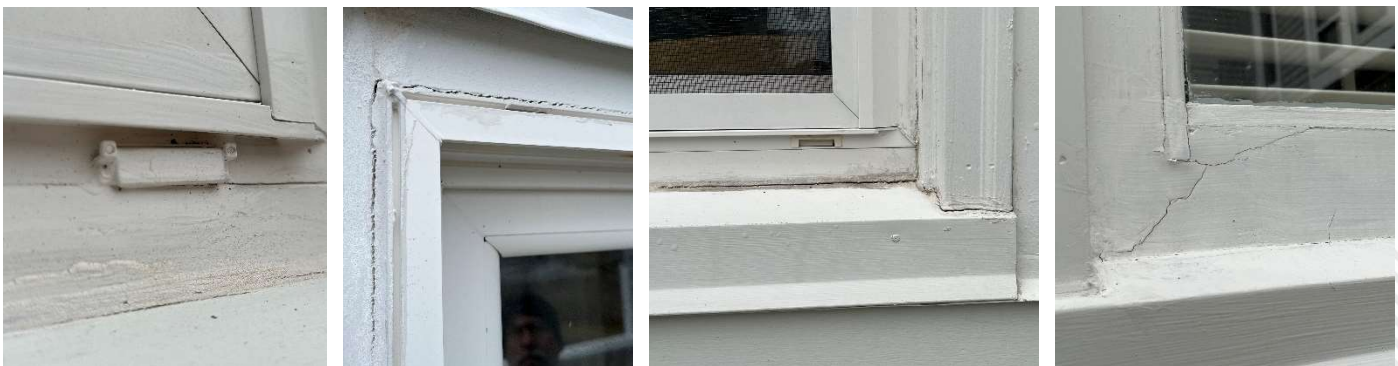
Photos 20, 21, 22, & 23 – Window sill weep painted closed (Left), Cracks, openings, and sealant delamination at window frames and trim (Center Left, Center Right, & Right).

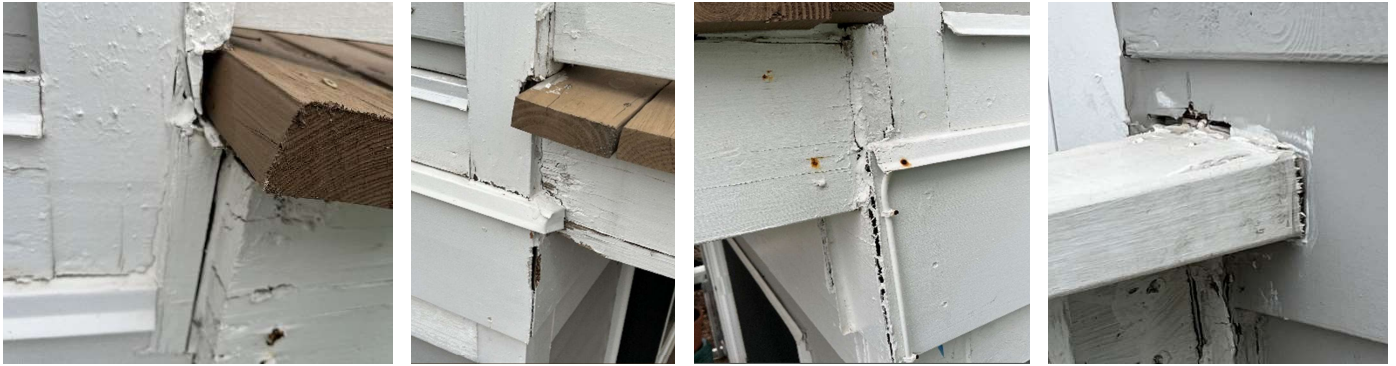
Photos 24, 25, 26, & 27 – Typical gaps, openings, and missing flashing at upper level decks and trim.

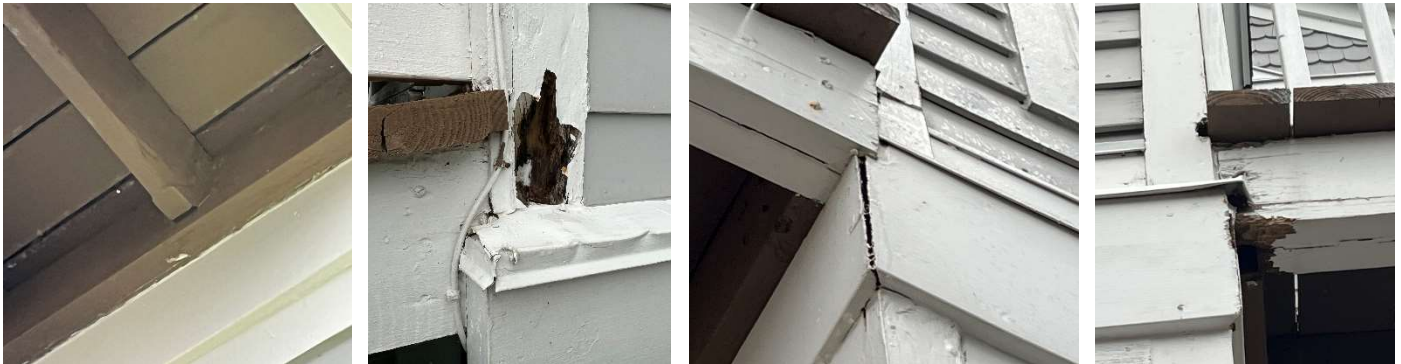
Photos 28, 29, 30, & 31 – Typical missing ledger flashing at upper level decks (Left), Typical corner trim rot (Center Left), Typical gap at corner trim (Center Right), and Typical rot damage to deck rim joist (Right).

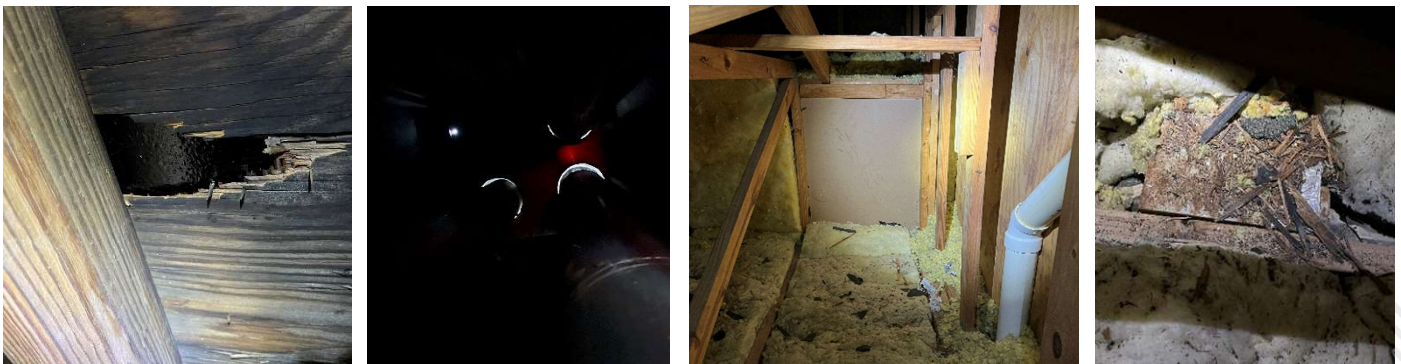
Photos 31, 32, 33, & 34 (Unit 108) – Damaged plywood roof decking at base of chimney (Left), Pinhole (upper left) in chimney cap (Center Left), Typical missing attic insulation at clerestory walls (Center Right), and Exhaust fan venting directly to attic space (Right).

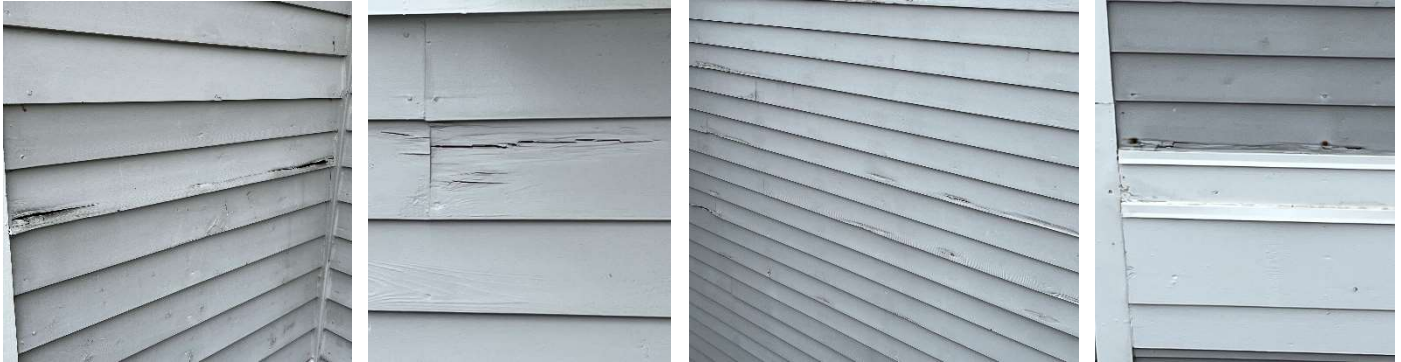
Photos 1, 2, 3, & 4 – Typical rotted siding throughout, numerous locations, multiple building elevations and areas.

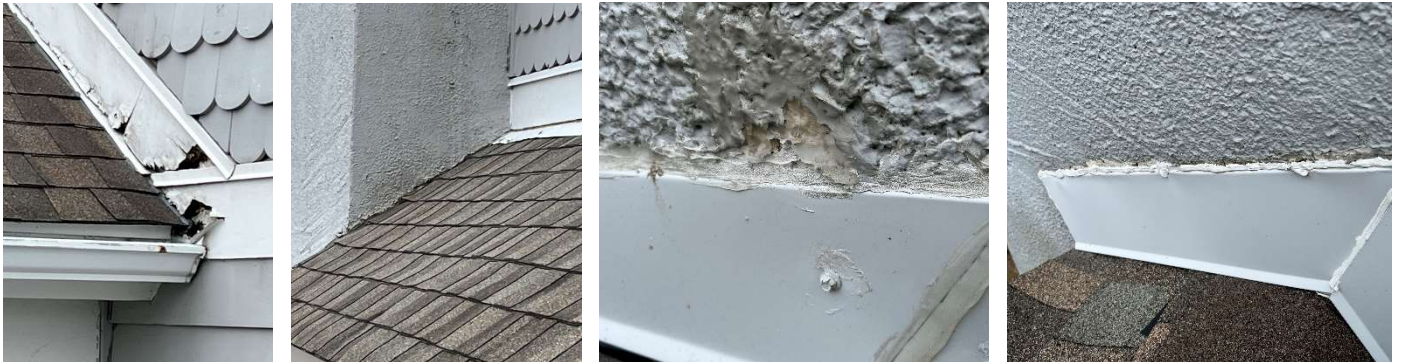
Photos 4, 5, 6, & 7 – Missing kick-out flashing (Left & Center Left), Degraded counterflashing sealant and tabby stucco coating at base of chimneys (Center Right & Right).

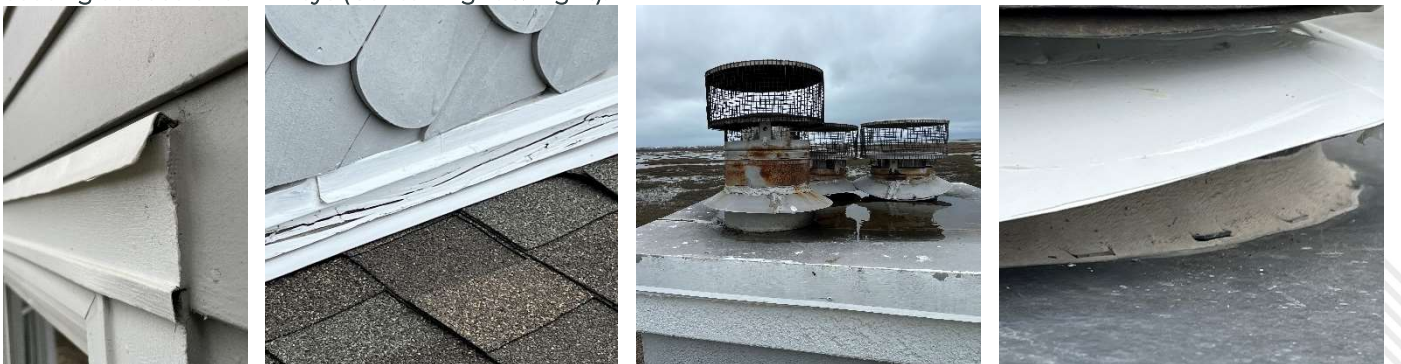
Photos 8, 9, 10, & 11 – Typical window trim flashing negatively sloped (Left), Typical end wall trim cracked & damaged (Center Left), Typical ponding water at chimney caps (Center Right), and Gaps at chimney cap/flue flange tabs (Right).

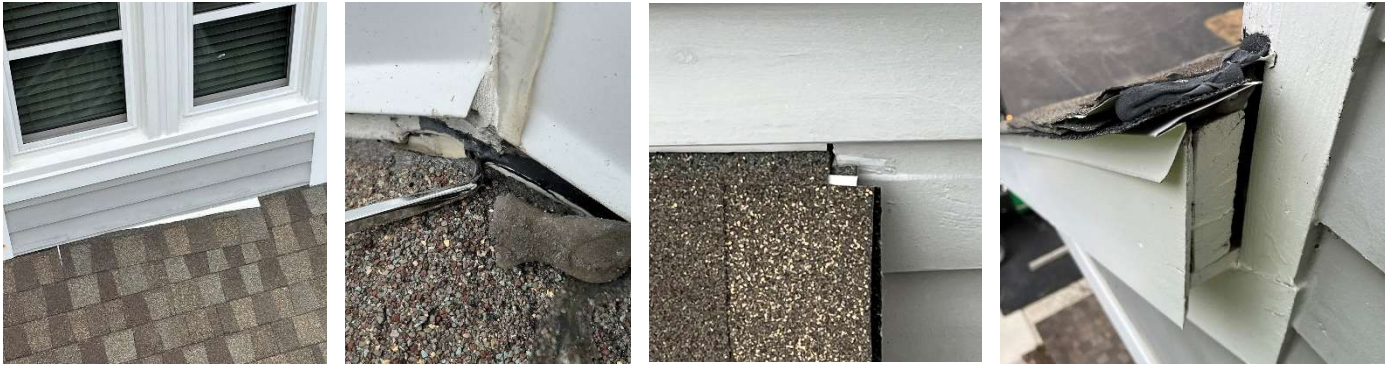
Photos 12, 13, 14, & 15 – Detached shingle at low roof west elevation (Left), Unsealed counter-flashing at ridge of chimney roof cricket (Center Left), Gap at end of roof apron wall flashing (Center Right), and Gaps at roof trim (Right).

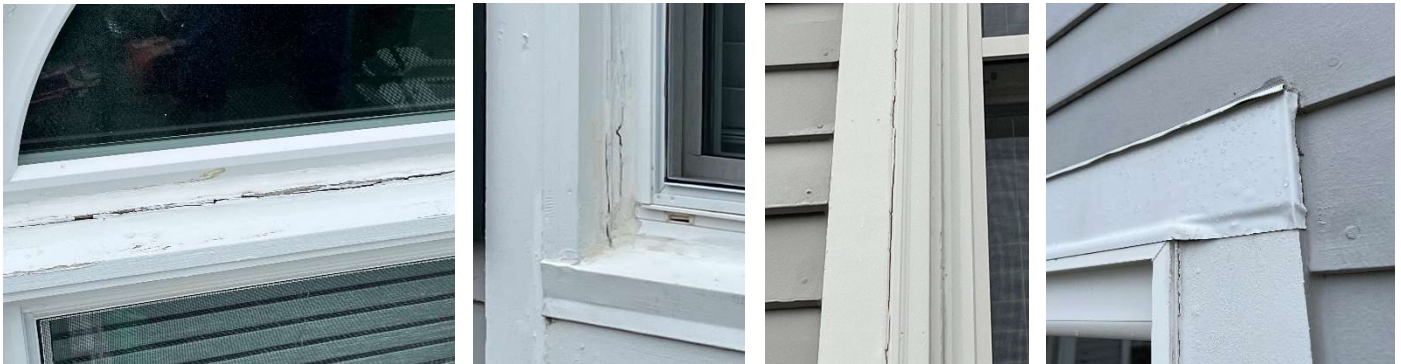
Photos 16, 17, 18, & 19 – Rotted transom window sill (Left), Cracks, openings, and sealant delamination at window frames and trim (Center Left & Center Right), and Evidence of prior temporary repairs to fenestration framing (Right).

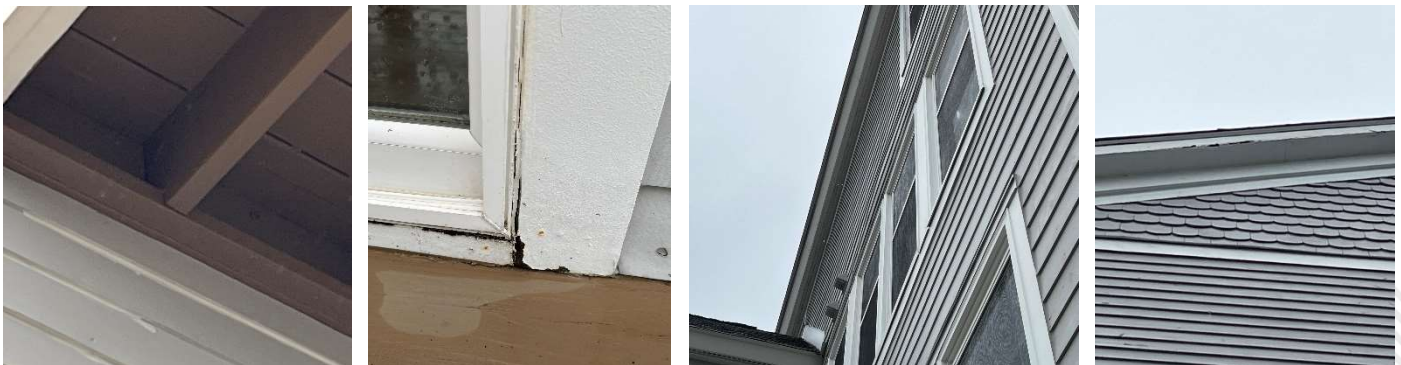
Photos 20, 21, 22, & 23 – Typical missing ledger flashing at upper level decks (Left), Typical trim rot at slider trim in contact with decking (Center Left), Bowed clapboards at east elevation (Center Right), and Typical rot damage to roof rake (Right).

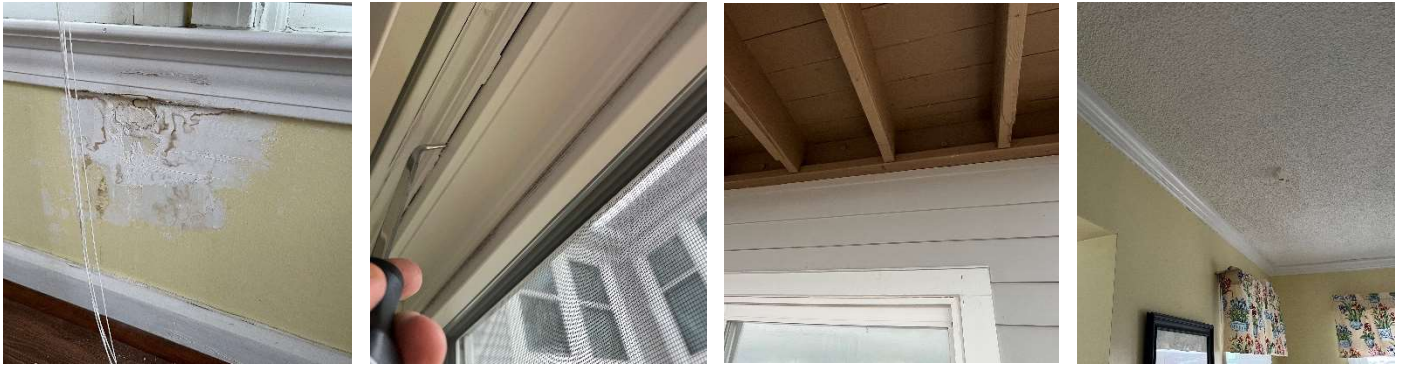
Photos 24, 25, 26, & 27 (Unit 202) – Damaged interior wall finishes (Left), Reported location of water intrusion at window frame interior (Center Left), Typical missing ledger flashing (Center Right), and Interior ceiling damage adjacent to exterior deck (Right).

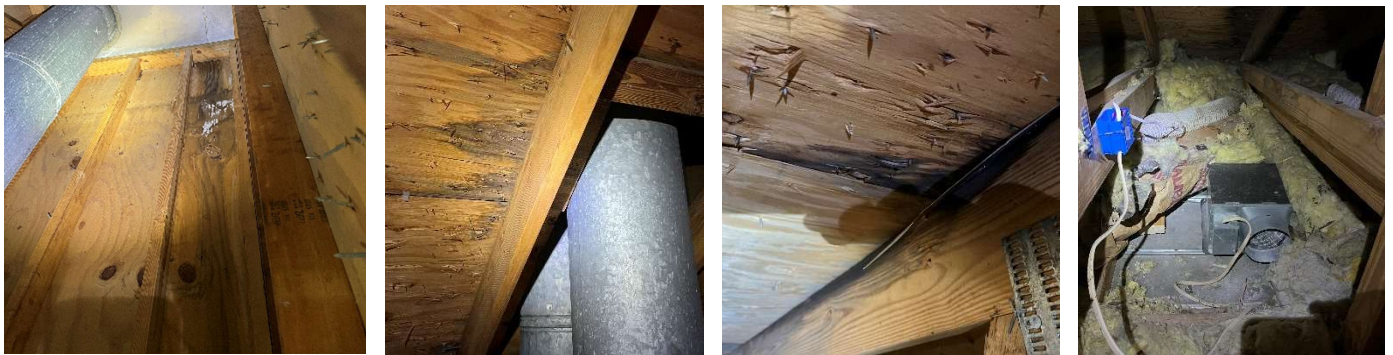
Photos 28, 29, 30, & 31 (Unit 205) – Damaged plywood sheathing at top of chimney interior (Left), Evidence of water infiltration/staining on roof decking (Center Left & Center Right), and Exhaust fan venting directly to attic space (Right).

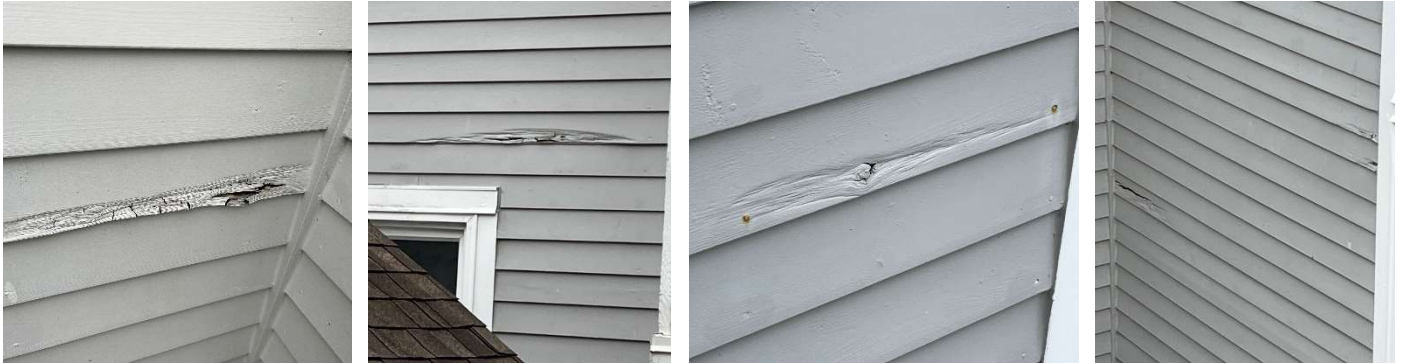
Photos 1, 2, 3, & 4 – Typical rotted siding throughout, numerous locations, multiple building elevations and areas.

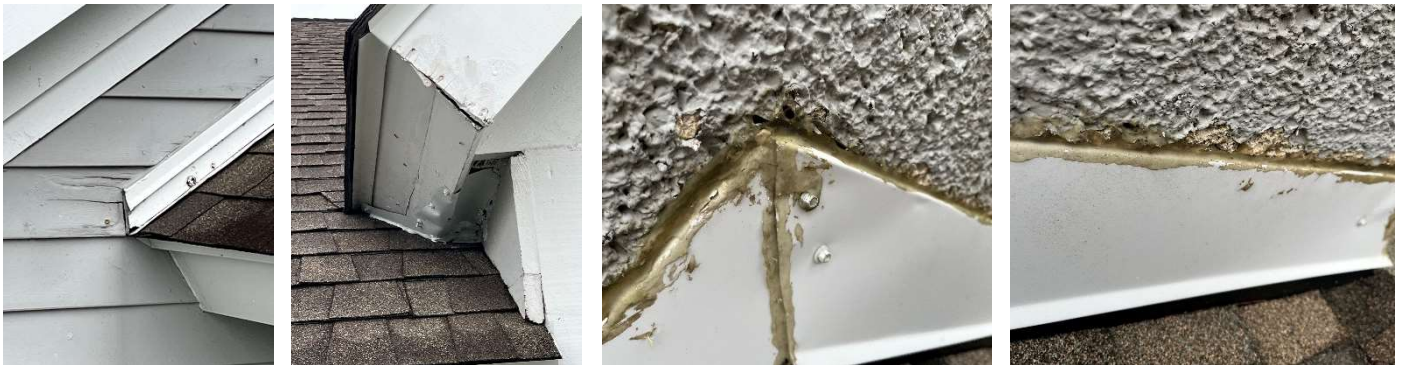
Photos 4, 5, 6, & 7 – Missing kick-out flashing (Left), Negatively sloped and sealed fascia trim repair (sheet metal) (Center Left), Degraded counterflashing sealant and tabby stucco coating at base of chimneys (Center Right & Right).

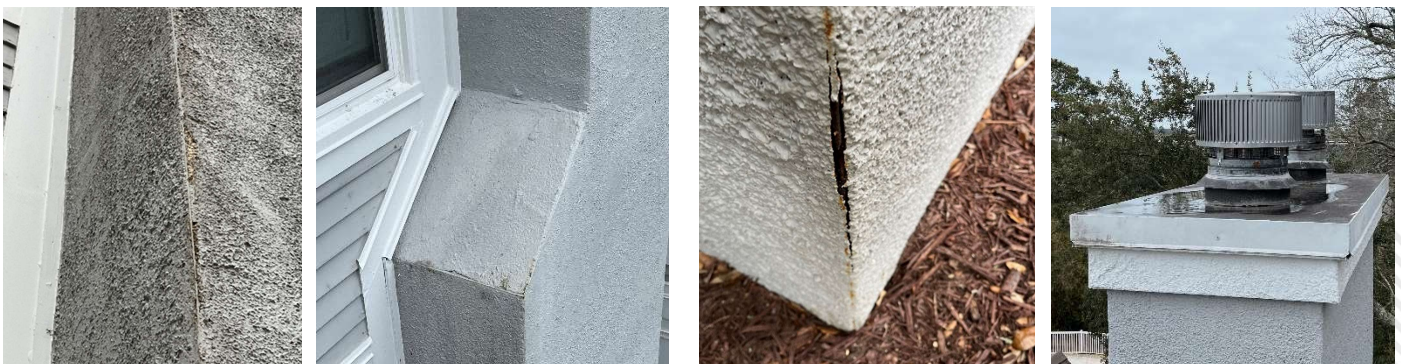
Photos 8, 9, 10, & 11 – Typical edge corrosion and decomposition of chimney tabby stucco (Left, Center Left, & Center Right), and Typical ponding water at chimney caps (Right).

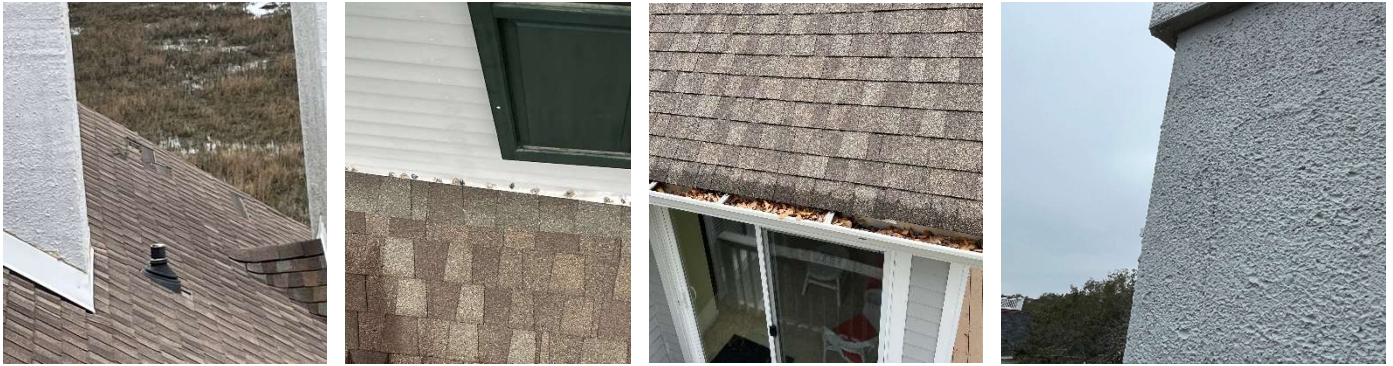
Photos 12, 13, 14, & 15 – Missing shingles at upper roof south elevation (Left), Missing shingles at low roof apron flashing (Center Left), Gutter debris (Center Right), and Typical cracking of tabby stucco at chimneys (Right).

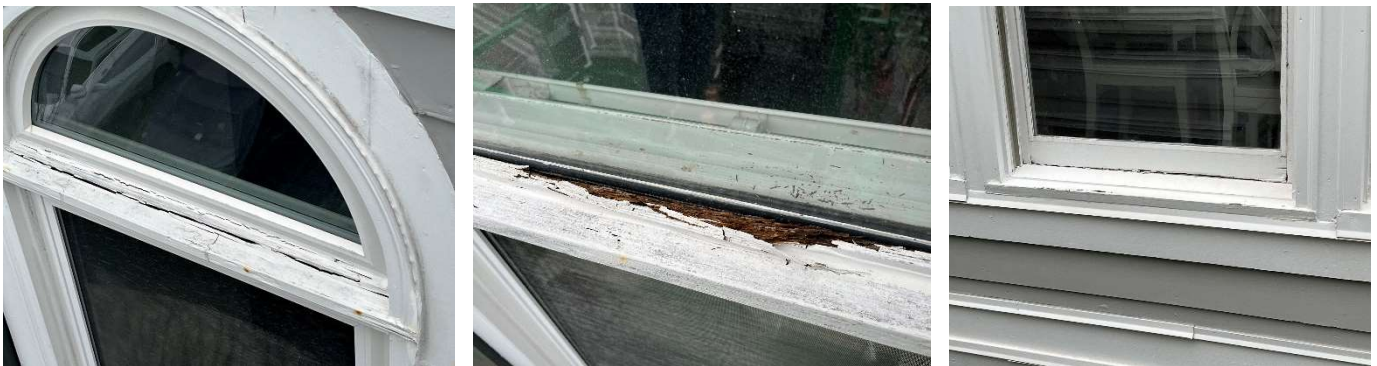
Photos 16, 17, & 18 – Rotted transom window sill (Left & Center), and Cracks, openings, and sealant delamination at window frames and trim (Right).

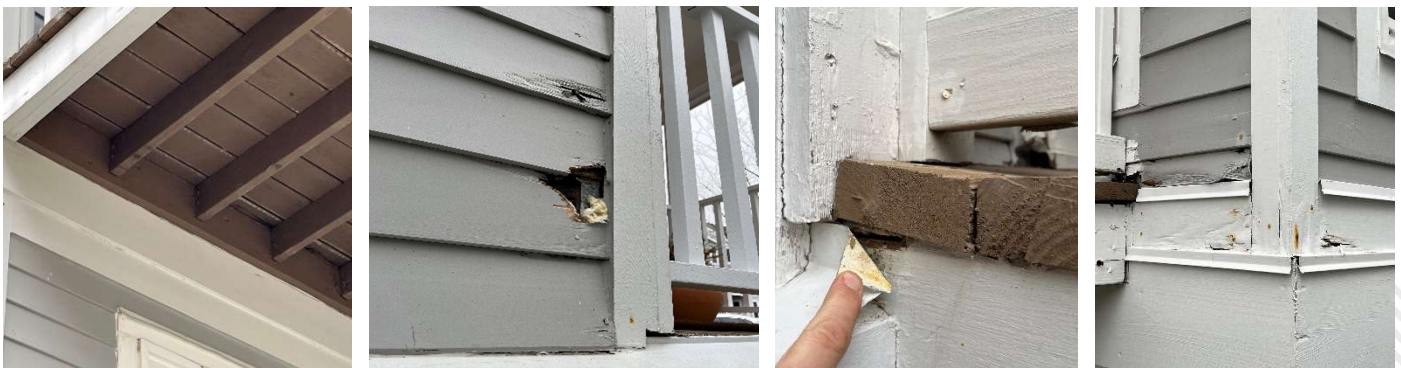
Photos 19, 20, 21, & 22 – Typical missing ledger flashing at upper level decks (Left), Typical siding rot (Center Left), Untermated siding flashing at deck (Center Right), and Typical rot damage to siding & trim (Right).

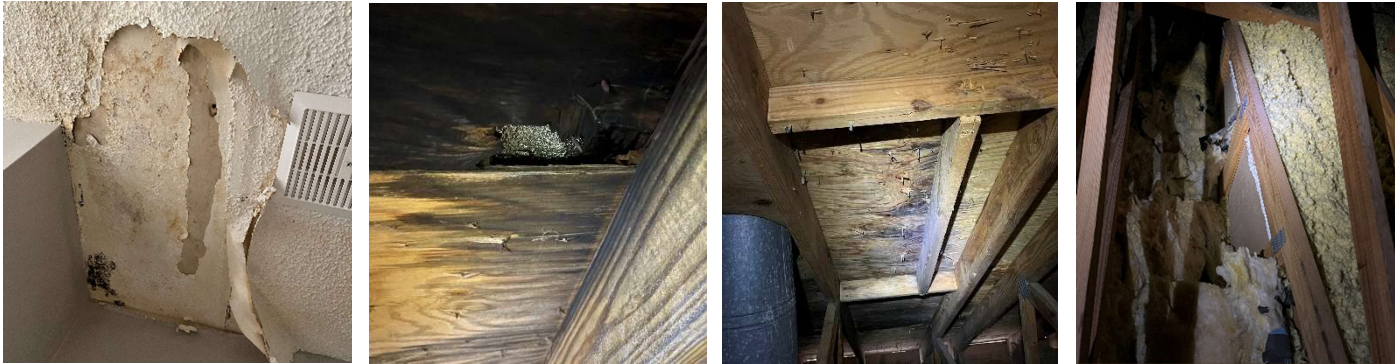
Photos 23, 24, 25, & 26 (Unit 305) – Damaged interior ceiling finishes (Left), Damaged plywood roof decking at base of chimney (Center Left), Evidence of water infiltration/staining on roof decking (Center Right), and Typical missing attic insulation at clerestory walls (Right).

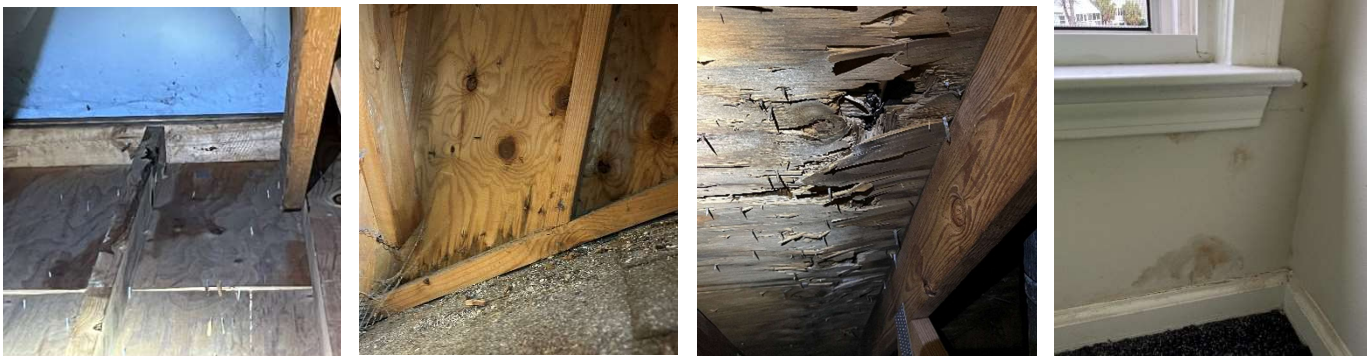
Photos 27, 28, 29, & 30 (Unit 306) – Damaged plywood sheathing at top of chimney interior (Left), Evidence of water infiltration/staining on roof decking (Center Left), Damage to roof decking at base of chimney (Center Right), and Evidence of water infiltration/staining on interior finishes below windows (Right).
